# Archeological Testing of the World War II Prisoner-of-War Camp (5EP1221) at Fort Carson, El Paso County, Colorado

Prepared for and funded by
The Directorate of Environmental Compliance and Management
Fort Carson, Colorado

Midwest Archeological Center National Park Service Lincoln, Nebraska

May 1999

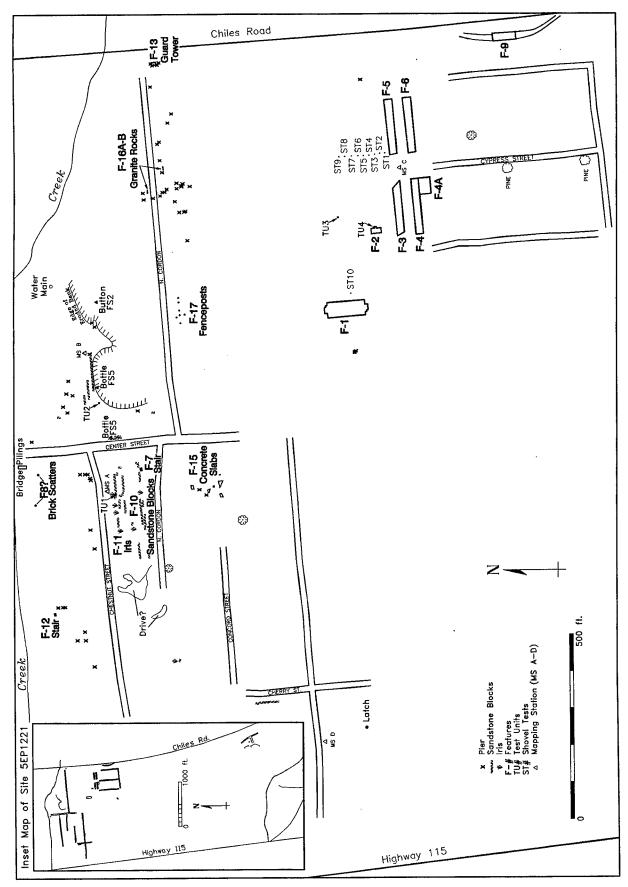
Figure 10a. Map of the archeological remains of the Fort Carson POW Camp, 5EP1221, north camp.

Excavations were conducted in four one-meter-square units. The units were plotted on the site map (Figure 10a) and excavated using 5-cm levels. All excavated material was screened through quarter-inch hardware mesh. Materials found in place were piece-plotted, and sediment samples were taken for each significant stratum. Photographs were taken before excavation, at the bottom of each level, and at the discretion of the field director. During excavations, the field director kept a set of master notes. The excavators also kept notes on Fort Carson–Pinon Canyon excavation forms. These forms require a description of the unit, the sediment, the depth of excavation, the artifacts found, and a plan map of the level (Dean 1992).

This area contained artifacts wherever erosion was occurring. Artifacts with potential to be temporally diagnostic were mapped and collected (Figure 10a). Fifty-eight sherds of a broken green glass bottle were collected (FS 5). The bottle has a crown finish and a round base. On the base the words "Duraglas, 2, Denver" are stamped. This is a container for a locally bottled beverage. Thirteen fragments of a clear bottle with an applied color label were also located (FS 4). The remaining writing states "Qwein's, ...ality, ...erages."

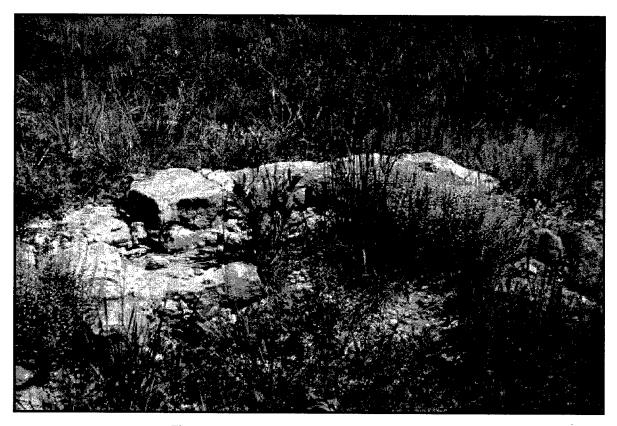
Figure 14. Feature 7, sandstone stairs. View to north.

Feature 7 is a set of sandstone stairs approximately 5'9" long and 3'5" wide. Feature 7 is associated with Feature 10, the sandstone block lines, and is directly adjacent to them. Feature 7 consists of two sets of risers and stairs (Figures 10a and 14). A third stair may be present, but would be buried under sediment. Each stair is approximately 5'9" across and 13¾" wide. The stairs are made of flat red sandstone slabs held together with concrete. Portions of the second stair from the top are missing, and rubble fills in the missing portion. There

is no building shown on the aerial photograph in the area of this feature where the stairs would lead, and there are no concrete foundation piers associated with the stairs or the sandstone bricks. Lines of sandstone bricks occur from the stairs and may have outlined garden areas.

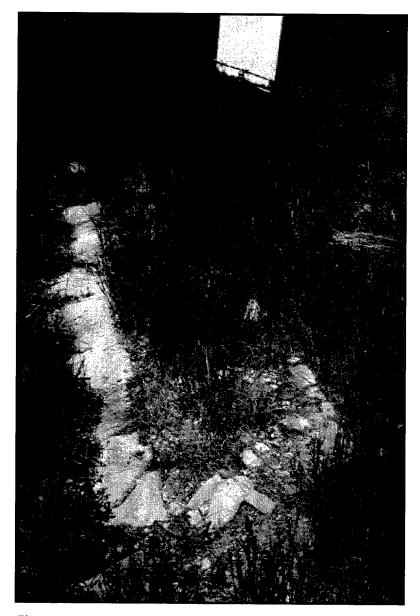
Figure 16. Feature 12, concrete foundations. Overview to the northwest.

Feature 12 consists of a concrete wall, piers, and a possible set of stairs (Figure 16). They are the remains of a building facing north. The concrete wall is approximately 9 to 10 inches wide and 100" long. This is associated with a large sandstone slab, which is possibly a set of stairs approximately 18" long and 11" wide. Four concrete piers are nearby. There are many broken fragments of window glass and "bubble glass" near the feature. The concrete wall extends underneath the present fence boundary.

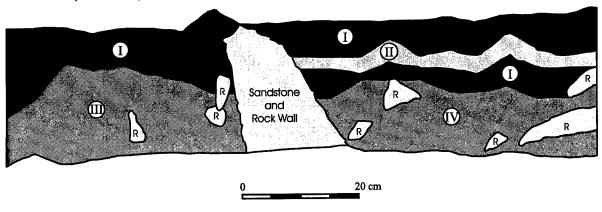
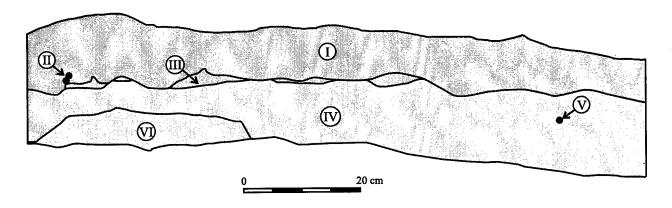
Figure 17. Profiles of Test Unit 1 and Test Unit 2.

## Test Unit 1 (West Wall)

- R Rocks
- I Dark Grayish Brown Sandy Clay
- II Light Reddish Brown Sandy Loam
- III Gray-Brown Clay Loam with 7% Gravel inclusions
- IV Gray-Brown Clay Loam with Gravel and Rock Inclusions-

## Test Unit 2 (East Wall)

- I Light Brownish Gray Sandy Clay with Gravel Inclusions
- II Nails
- III Rust Stains in soil Associated with Nails
- IV Gray-Light Gray Sandy Clay with Granite Inclusions and Caliche
- V Coal
- VI Very Pale Brown Sandy Loam with Gravel and Rock Inclusions

The soil in the upper 7 cm of the unit was generally loosely packed and had some gravel and small rock intrusions (Figure 17). Below the top of the sandstone wall, the soil was noticeably different on the north and south sides of the wall. About 8 cm below surface, a layer of red-orange sandy soil appeared on the south side of the sandstone bricks. This layer of red-orange sandy soil varied in thickness from 1 to 11 cm on the south side of the bricks. Under the red-orange sandy soil was a layer of dark brown clayey soil and closely packed rocks (mostly of granite) ranging in size from 2 to 12 cm. The soil on the north side of the sandstone wall was a lighter brown than that on the south side and became clayey in some areas by 15 cm below surface. Two areas of red-orange clay appeared near the northern edge of the unit at about 13 cm below the surface.

The metal detector was used along this area to indicate the density of potential artifacts. The detector noted artifacts all along the edge of the bank. TU2 was placed in an area of very dense "hits." The first 10 cm (Figure 17) consisted of a sandy clay soil, with 10 to 20 percent gravel inclusions, and a number of artifacts. Several rust stains were noted in the bottom of this deposit, which were associated with iron nails.

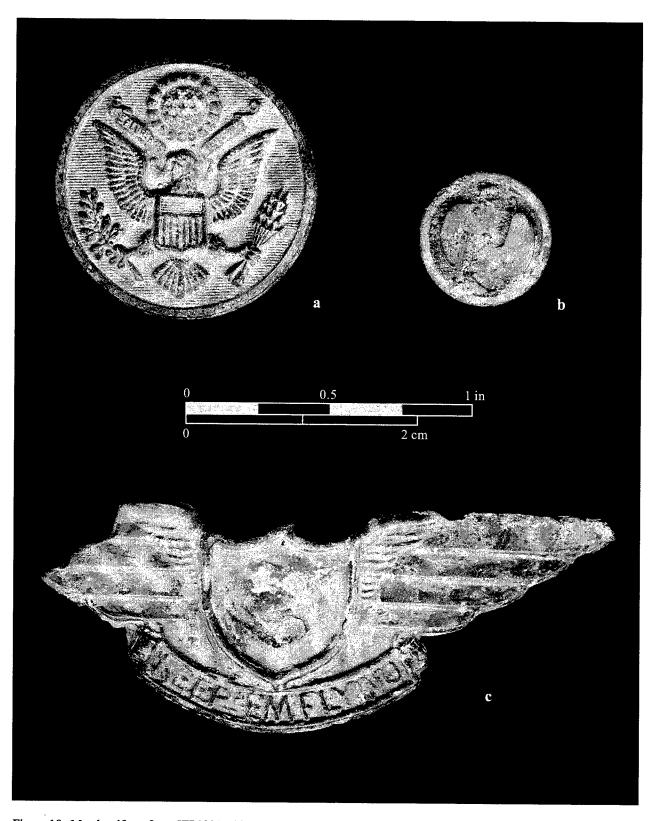
Figure 18. Metal artifacts from 5EP1221: (a) FS 2, Pattern 1912 military button; (b) FS 29, a metal clutch back of an early World War II design; (c) FS 6, portion of a badge with the motto "Keep 'em Flying".

Also found on the surface here was a lightweight cabinet hasp (FS 3). FS 2 is a military button, with a backmark of "Waterbury." This is a Pattern 1912 button, and the same button style has been in use from 1912 to the present (Figure 18a).

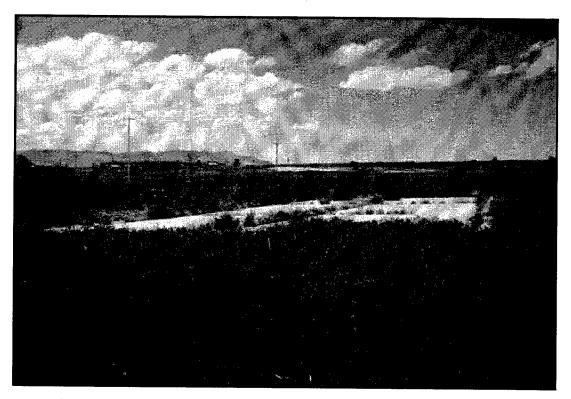
Figure 20. Feature 1, a concrete-slab building footprint. Overview to the northwest.

Feature 1 is a concrete-slab building footprint, approximately 100' long and 39.5' wide, located between the eastern and center compound of the northern POW camp. It is a rectangular footprint with a concrete ramp attached to either end (Figure 20). This is a foundation consisting of six large (16' x 30') concrete slabs bordered by smaller concrete blocks (3'9" in width). The blocks on the outside of the foundation are separated by metal dividers (¼" thick). Two concrete ramps slope downward from either end of the foundation. Iron and wood supports are present along the on the west of the foundation. Only iron supports are present on the east. The wood component of the support system is not present and has probably rotted away on the east. These were probably used to support the structure's walls.

The concrete slabs are cracked, and the blocks on the outside edges of the foundation are crumbling. When originally poured, the concrete was not spread evenly. Careless pouring of the concrete is also indicated by the impression of a large tire rut in the southeast corner. An inscription in the concrete reads: "3rd PLT CO. D 7th ENGR BN," suggesting the platoon responsible for pouring the slabs (Figure 21).

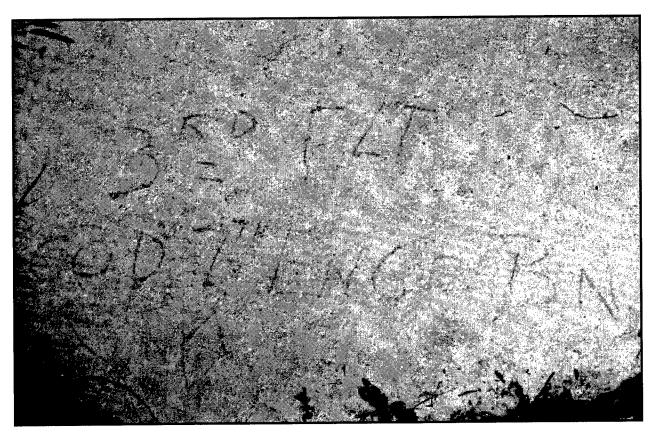
Figure 21. Inscription on the floor of Feature 1.

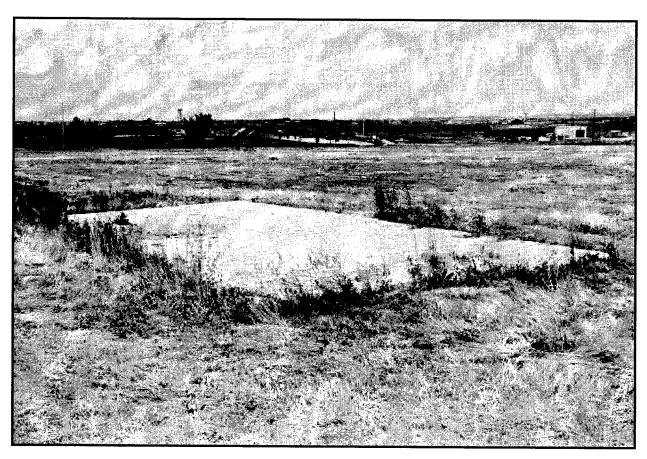
Figure 22. Feature 2. View to the northeast.

Feature 2 is a concrete-slab foundation in the eastern compound of the northern POW camp (Figure 22). The plumbing in the floor suggests the building may have originally related to a lavatory or laundry facility. The footprint consists of a rectangle with a small (about 4' x 4') entryway. A layer of red soil is present on the ground surface near Feature 2. This may have been used for landscaping, since a similar layer was found in the garrison echelon area. Broken gray and red-patterned linoleum fragments are attached to the concrete floor in some areas. Fragments of linoleum and glass extend away from Feature 2 up to about 15 feet. A manhole is located south of Feature 2 between the feature and the road.

This feature is in roughly the correct place for the lavatory for one of the 250-man companies in the eastern compound on the POW camp plans. However, the plans for the trailer court show a laundry facility in approximately the same location. It is likely that the trailer court may have taken advantage of some of the existing suprastructure and re-used some of the plumbing and sewer facilities from the POW camp. Similar linoleum was found near the existing tennis courts, in the location of the former 5,000-man camp. This would strengthen the argument that components of this feature date to the POW Camp era. In addition, this is the location of a structure no longer present on the 1961 topographic map, suggesting that the structure was not standing in recent decades.

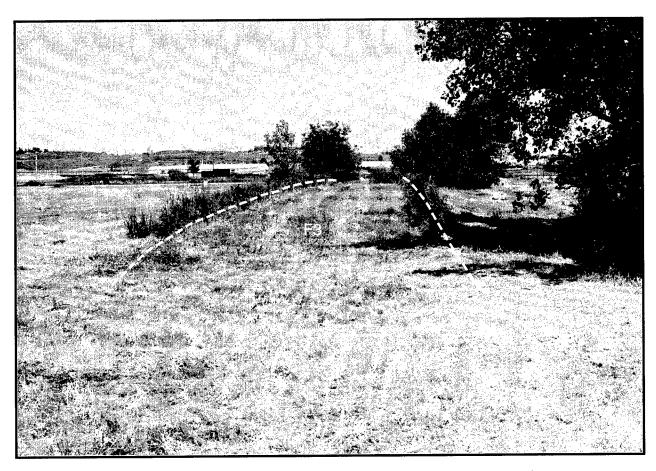
Figure 23. Feature 3. View to the east. Dashed lines indicate Feature 3 location.

Feature 3 is a concrete pad 175' x 20' (Figure 23). Remains of the concrete foundation extend east-west. Remnants of the walls are also still there. The southern wall extends 175', and the northern wall extends 160' and ends in rubble on eastern end. The walls have iron support brackets set in the concrete every 80". The interior of the structure contains small amounts of glass on the surface. The walls sink below the ground surface on the western end of structure, leaving only small pebbles visible. The concrete foundation consists of a rough concrete base with gravel inclusions, covered by a finer concrete wash that has no gravel inclusions.

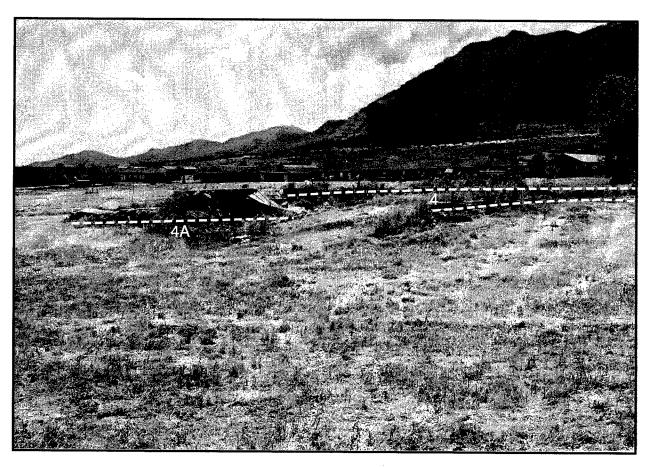
Figure 24. Feature 4. View to the southwest. Dashed lines indicate Feature 4 and 4A location.

Feature 4 (Figure 24) consists of a concrete foundation with partial walls about 150' long and 20' wide. Feature 4A is a bi-level concrete floor approximately 55' long and 30' wide that extends south from Feature 4.

The west, north, and south walls of Feature 4 are still standing. The southwest corner of the foundation is in the roadway. The foundation walls in Feature 4 are constructed of concrete and are between 8 and 10 inches wide where they are molded into walls and exposed on the surface. Underneath the surface of the ground, the concrete does not appear to be molded into a wall (with right angles), and it measures about 15"

wide where it is exposed. Iron bolts project from the top of the foundation walls on the north wall about every 9".

The north and south walls of Feature 4 are mostly exposed on the surface. The wall on the west end is almost entirely below the surface. The interior of Feature 4 is primarily lower than the walls and is littered with fragments of sawn lumber, nails, and concrete. The upper and lower concrete platform floors of Feature 4A are cracked, broken, and crumbling in many areas. There is a 10'-x-2' section in the center of the south side of the upper platform that has broken away completely. A concrete ledge (2' wide) extends from the northern edge of the upper platform of Feature 4A to or on top of the southern wall of Feature 4. The ledge and the wall appear to be of equal height.

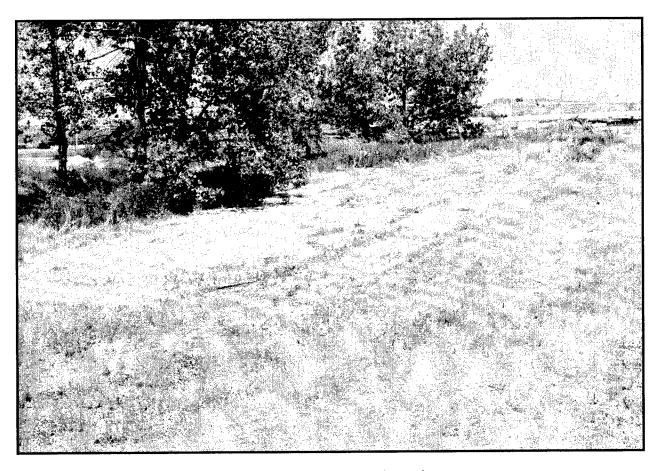
Figure 25. Feature 5. View to the northeast.

Feature 5 (Figure 25) is a rectangular concrete pad approximately 175' long and 20' wide. The structure consists of concrete slab foundation, with a raised surrounding foundation wall. Remains of concrete foundations extend east to west in the form of walls. The concrete base contains large gravel inclusions, washed with finer concrete with no gravel inclusions. The northern and southern walls are nine inches thick, and extend 175'. The western portion of structure contains a concrete floor that extends for 100 feet. This floor is littered with concrete rubble, glass, and refuse. The center of the structure contains concrete rubble, bits of metal, and gravel. One portion of rubble is covered by a layer of asphalt. The remaining 75' section of the eastern end of the structure lacks the cement floor. Some chunks of cement rubble are scattered inside and outside the eastern end. A 15' section at the end of the northern wall has fallen over.

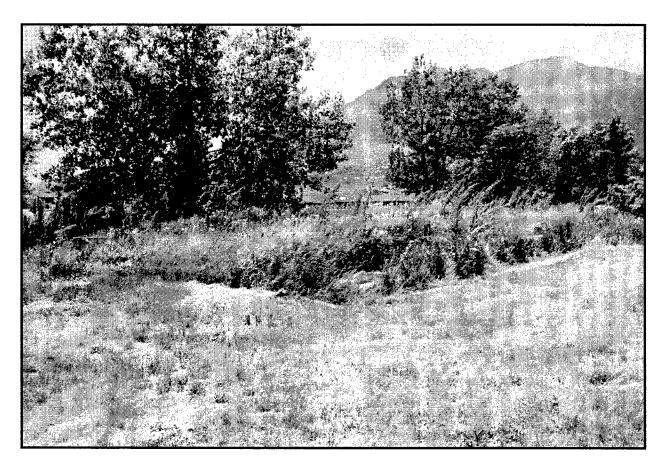
Figure 26. Feature 6. View to the southwest.

Feature 6 consists of a concrete pad approximately 175' by 20' (Figure 26). Remains of the concrete foundations extend east to west in the form of a wall. Concrete bases contain large gravel inclusions, washed with a fine concrete with no gravel inclusions. Northern and southern walls are nine inches thick. The northern wall extends 175'; the southern wall turns to rubble at 165'. The structure contains a concrete floor, which extends the entire length of the structure. The central portions of the floor are now rubble, and support vegetation. Grass and small bits of metal are scattered throughout. The easternmost end of the structure is mostly rubble, with only the northern wall intact. The eastern end of the structure also contains several pieces of iron rebar, and two metal pipes along the northern wall.

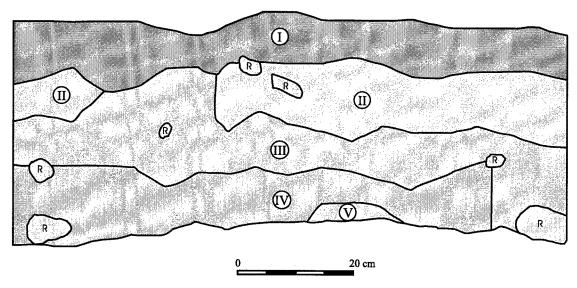
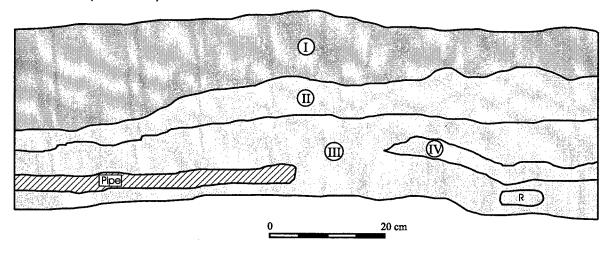
Figure 28. Profiles of Test Unit 3 and Test Unit 4.

# Test Unit 3 (East Wall)

- R Rocks
- I Grayish Brown Loamy Sand
- II Reddish Yellow to Pale Brown Loam with Approximately 40% Gravel Inclusions
- III Light Brownish Gray Sandy Loam
- IV Reddish Brown to Pale Brown Loam with Approximately 40% Gravel and 15% Cobble Inclusions
- V Light Brownish Gray Clay Loam

# Test Unit 4 (East Wall)

- R Rocks
- I Brownish Gray Loam with 5% Gravel Inclusions
- II Reddish Yellow to Pale Brown Sandy Loam
- III Light Brownish Gray Clay Loam
- IV Reddish Yellow to Pale Brown Sand

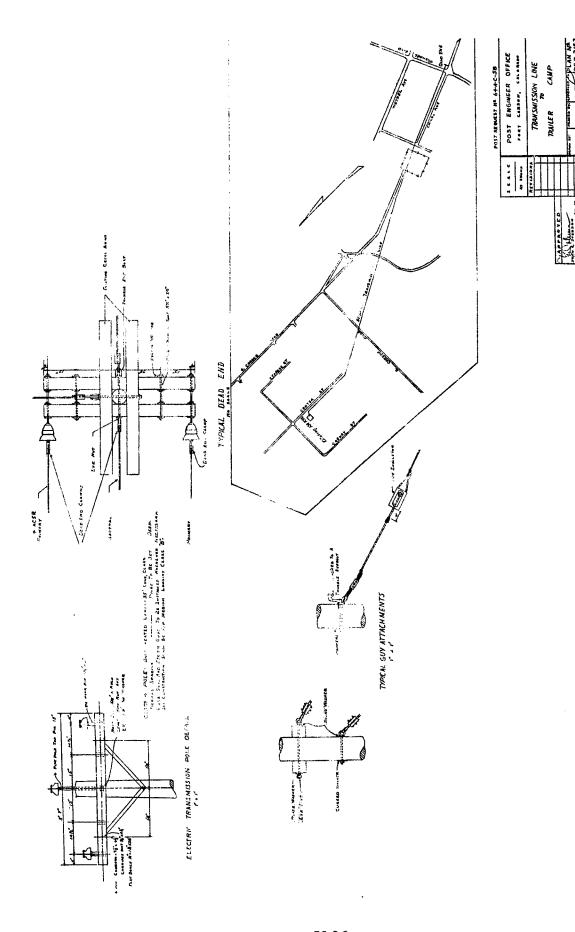
Figure 29. Plan PER 215-2. Transmission line to trailer court. Test Unit 3 contained a guy attachment as shown, indicating that a portion of the trailer camp was constructed on the internment camp.

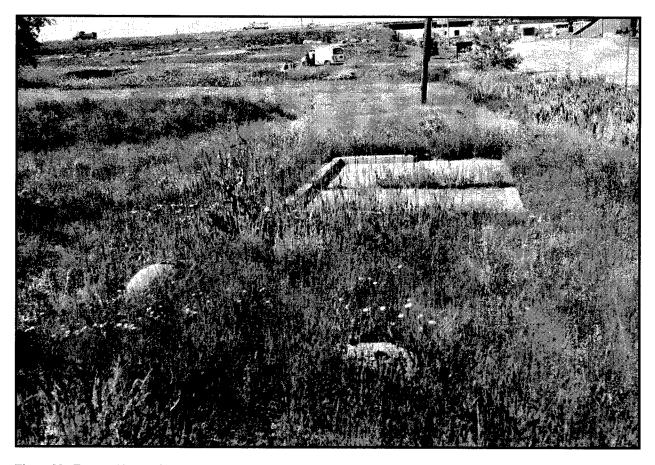
Figure 30. Feature 13, remains of concrete piers. These piers were probably the base for a guard tower at the POW camp. View to the north.

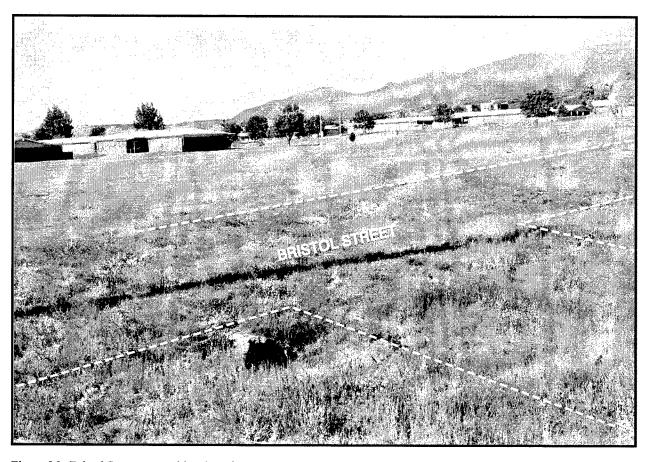
Figure 36. Bristol Street on outside edge of 5,000-man camp. View to the Southwest. Culvert empties into drainage ditch on side of former road.
